Thermal Imagers and Marine Inspections

By Charles J. Hazouri,

Offshore Marine Inspections

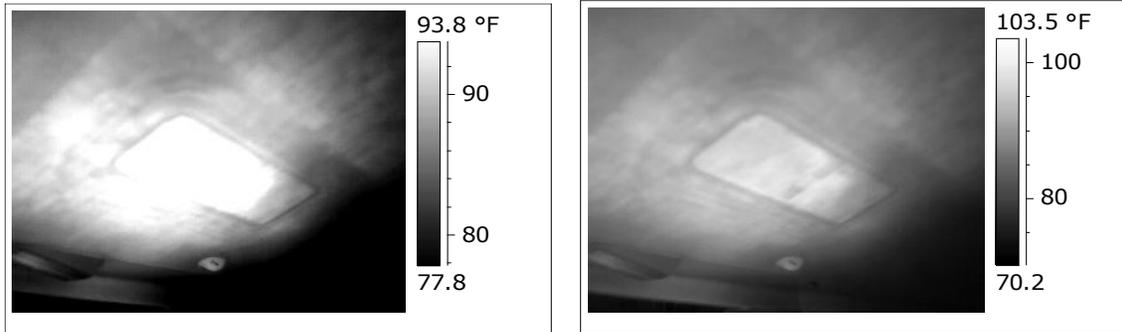
The image on the left is an example of an image from the T440BX that has not been thermally tuned using the computer's software. As you can see, there are numerous areas of reduced contrast, distortion, and some areas that could be mistaken for anomalies, unlike the image on the right, which has been thermally tuned.

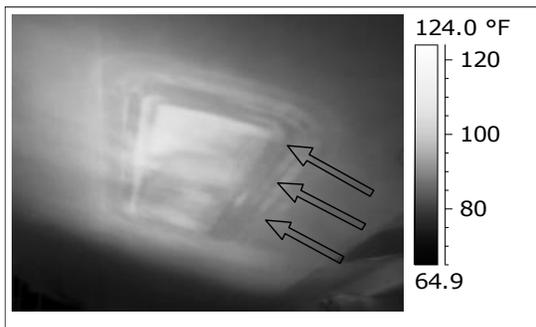
FLIR T440BX

As you can see, the above images show that the T440BX gives you the definition and delineated edges needed for proper inspection. The T440BX actually shows the layers of tabbing for the fiberglass insert, indicated by the black arrows in the images above.

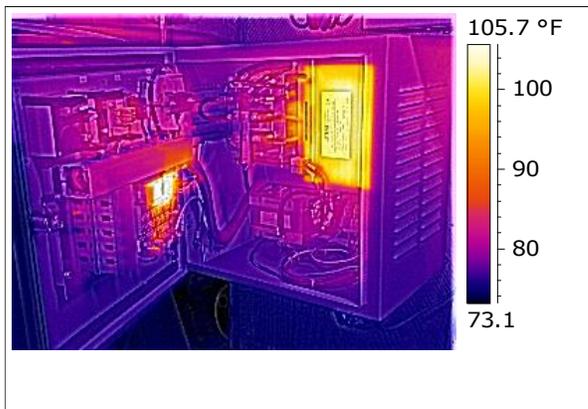
FLIR T440BX

As you can see in these images, the T440BX gives you definition and delineated edges for the electrical inspection. The FLIR One image was slightly distorted. A clearer image is necessary when using MSX[®] so the inspector can identify the problem area with enough detail to provide useful advice and/or information.

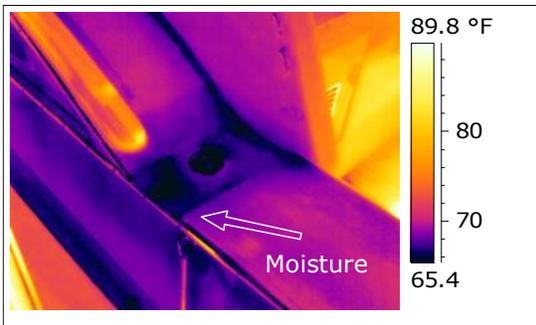
FLIR T440BX

As you can see, the T440BX give you the definition and delineated edges for the inspection. With the Spot1 (Sp1) and Sp2 temperature readings, the T440BX and E6 show close to a ten degree Fahrenheit temperature difference, while the C2 showed just under a six degree temperature difference. The E6 is slightly distorted while the C2 and FLIR One are quite distorted and do not show what you need to do a proper inspection by defining the actual area of concern as indicated by the black and white arrows. An actual Delta T could not be determined in the FLIR One image.

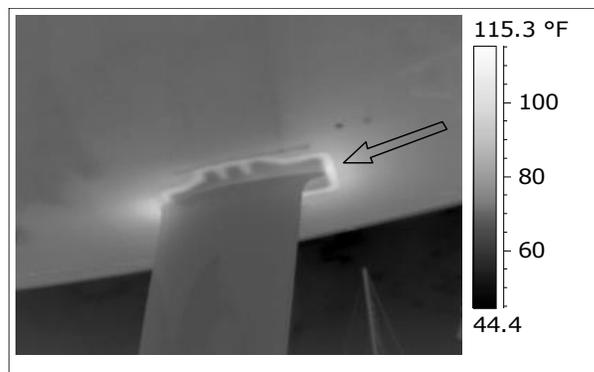
FLIR T440BX

The above images show that the T440BX gives you the definition and delineated edges for good inspection. The C2 is distorted and does not show what you need to do a proper inspection.
